# CITY OF ASTORIA

## Historic Properties – Design and Materials

### Stairs / Railings / Decking

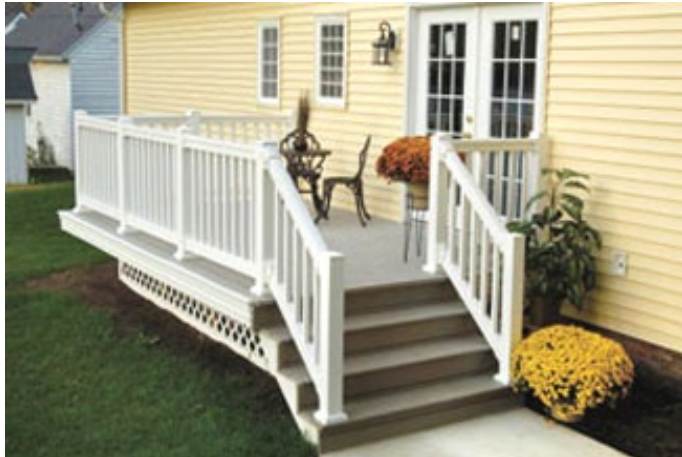
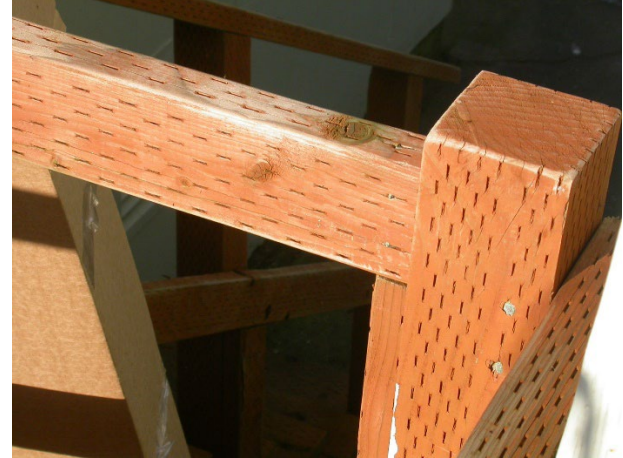
SPINDLE ENDS should be enclosed within the upper and lower rails, as pictured to the left.

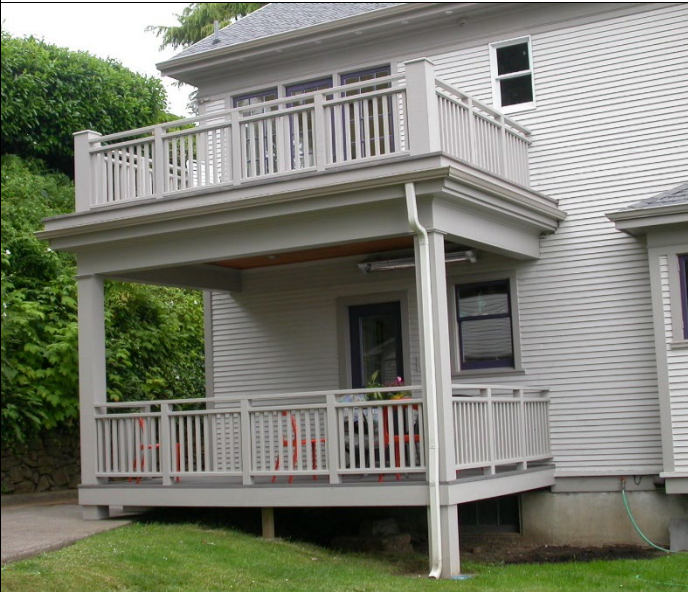
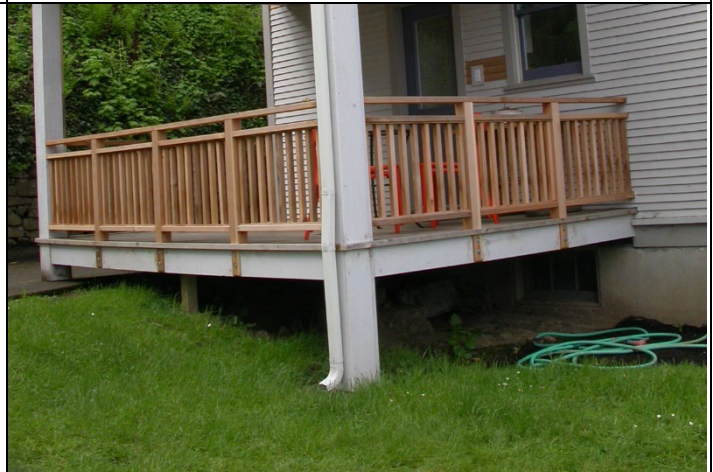
INCISION/CLEAT marks are not allowed.

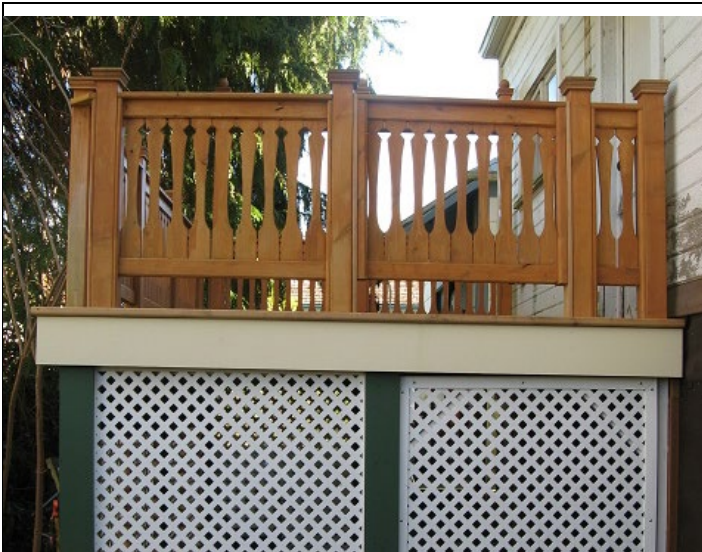
INCORRECT: Unpainted wood; Posts need to be covered similar to the picture to the left

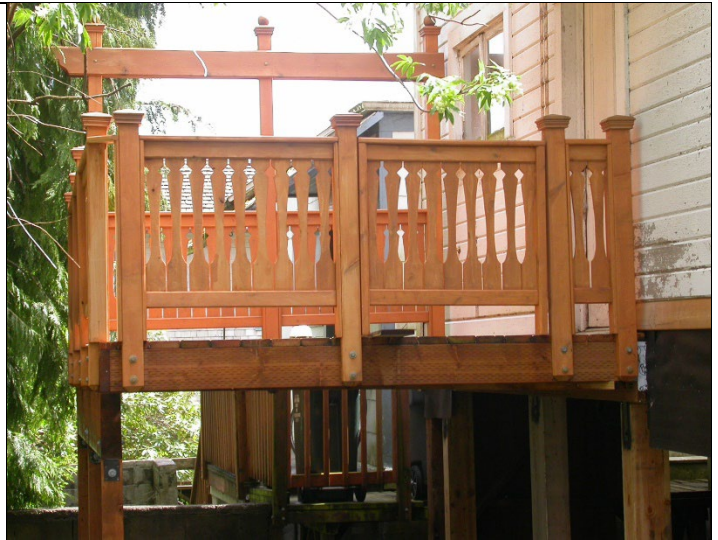
Correct: Supports covered with fascia board; Decking extends past the support and posts; Enclosed below with framed lattice or other approved enclosure.

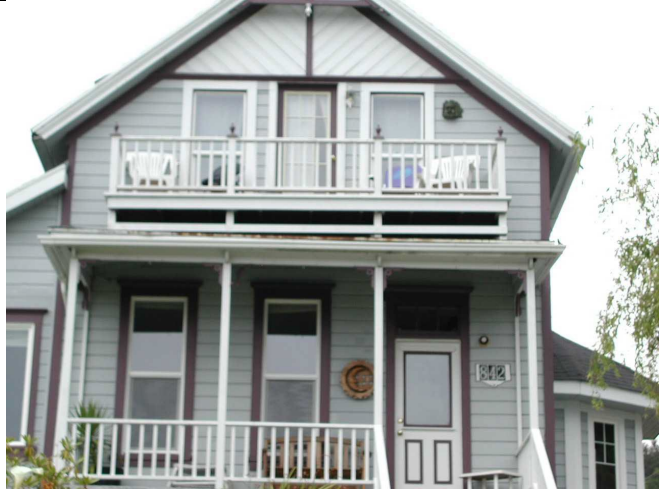
Incorrect: Supports on outside of decking visible/exposed; Open below deck with visible supports.

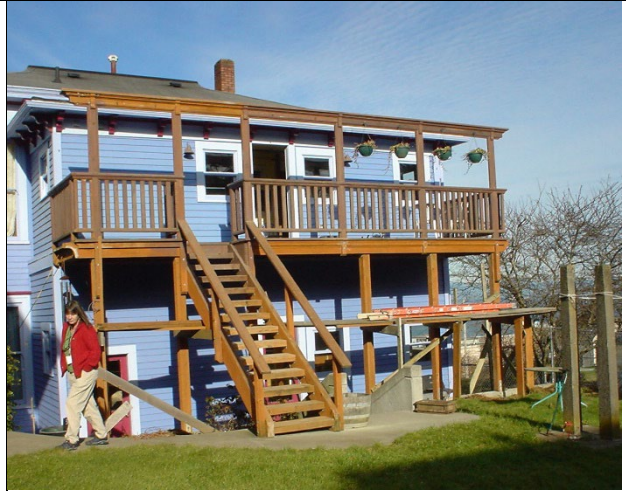
Correct: Support posts line up with 1<sup>st</sup> and 2<sup>nd</sup> floor; balusters are within proportions and meet historic characteristics.

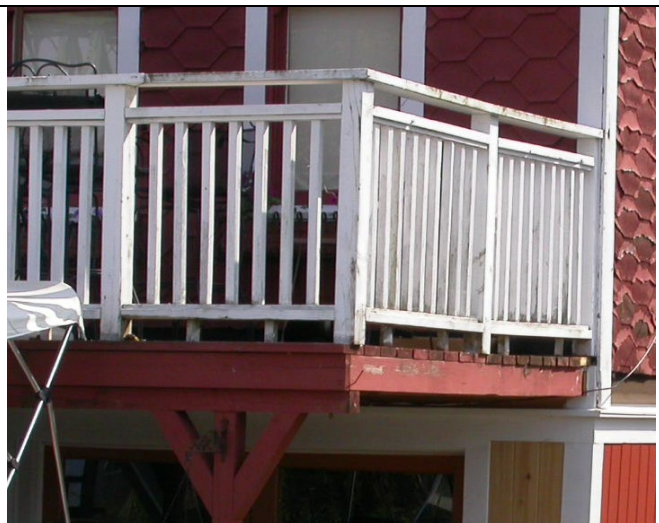
Incorrect: Support posts do not line up between 1<sup>st</sup> and 2<sup>nd</sup> floors; balusters too tall; handrail extends past post; no spindles along staircase.

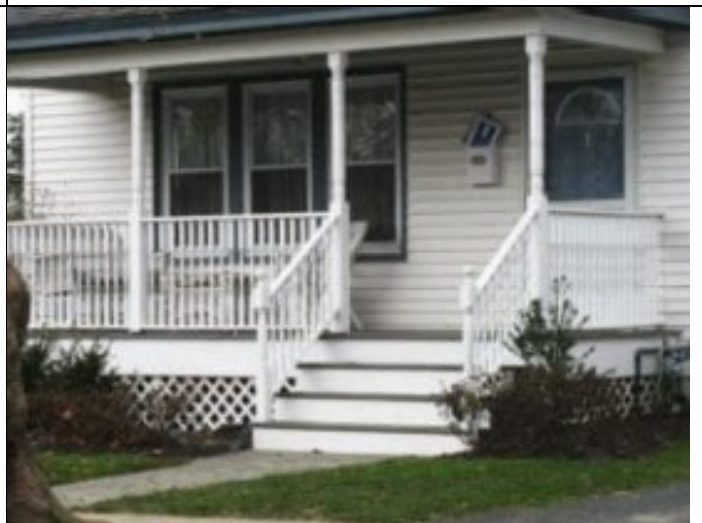
Keep handrails simple and low. An open upper rail can be added to help meet required building codes.
